| Clutches | Solid Flywheel Conversion Kit | 835013 | Mercedes

Vibration occurring in the vehicle

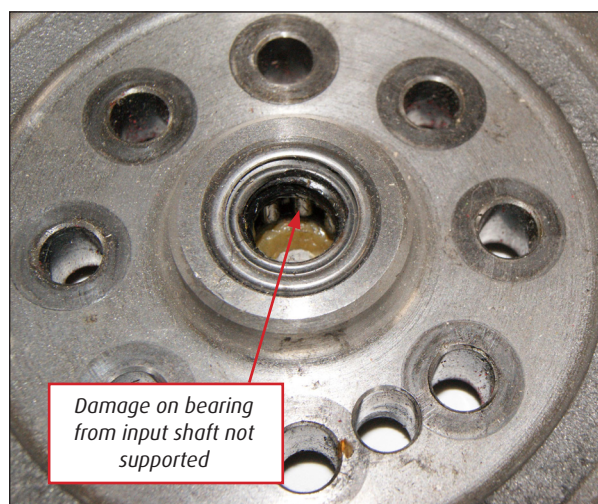
When the gearbox is mounted after having a conversion kit fitted, care needs to be taken to ensure the input shaft is mounted into the spigot bearing in the flywheel centrally and the gearbox needs to be fully supported to ensure the first motion shaft is not allowed to damage the pilot bearing. If the pilot bearing is damaged, the first motion shaft will not be fully supported or can cause the shaft to rotate eccentrically. This will then produce a vibration in the gearbox and will accelerate wear on the gearbox components.

Right is an image of the pilot bearing damaged in a flywheel that was returned for a vibration issue.
