T.S.B. No.:
CL001 / 08

PRODUCT:
Clutch

MARQUE:
All makes with Dual Mass Flywheel

SUBJECT:
Failed Dual Mass Flywheel

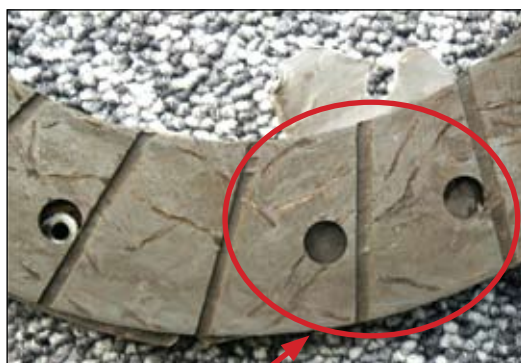
Drive plates that exhibit signs of slippage, thermal damage to the friction material, shifting of the friction material between rivets and excessive spline wear will indicate the DMF is worn or faulty. Before fitting a new clutch, the DMF should be checked for wear. Visually inspect the condition of the drive plate mounting face. If thermal bluing or thermal cracks in the surface are evident the flywheel should be replaced.

Image showing shifting of friction material between rivets

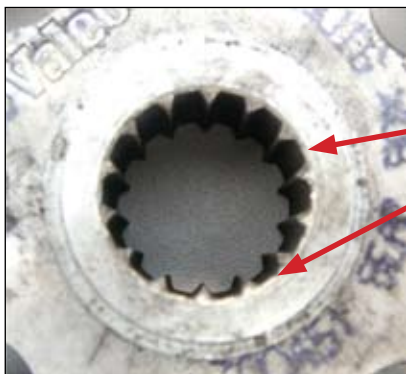
Image showing wear to spline teeth from excessive free rotation in the secondary mass

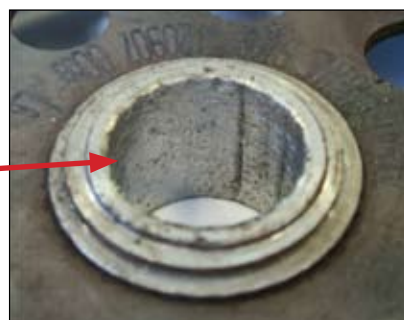
In extreme cases, the free movement in the secondary mass can result in the total loss of the drive plate hub splines

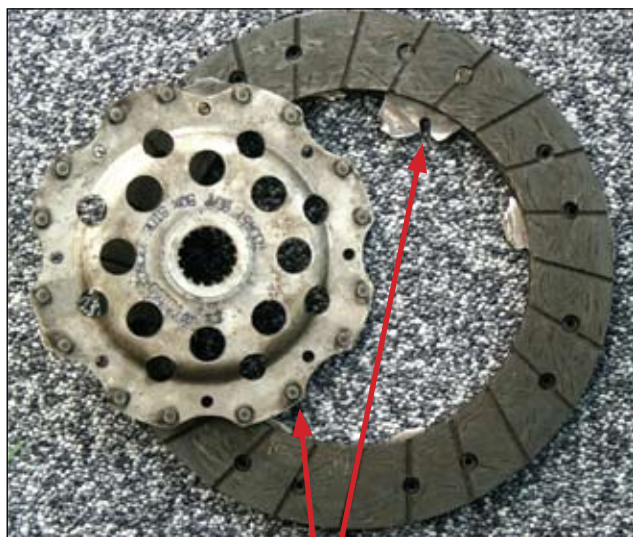
Failure of the cushioning plate riveting at the drive plate hub can also occur
