T.S.B. No.:
CL003 / 08

PRODUCT:
Car and LCV Clutch

SUBJECT:
Unable to select
gears/worn
diaphragm fingers/
collapsed bearing

Technical Services **Bulletin**

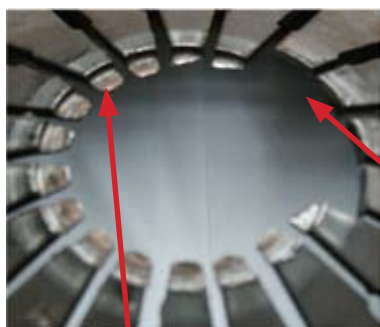
Image 1 shows a typical cover that displays evidence of the bearing having an incorrect pre load, and clearly demonstrates the type of damage that can be seen on the cover when the clutch is removed.

Image 1
Excessive wear and bluing of
the diaphragm fingers

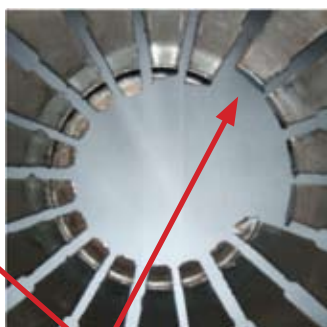
Diaphragm fingers worn through

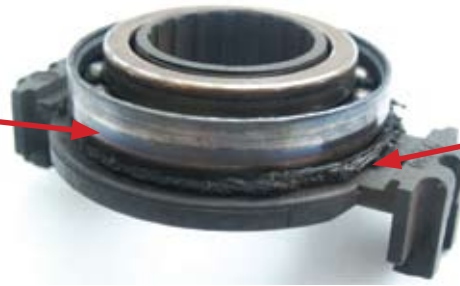
Image 2

The cause of the failure is incorrectly diagnosed as a collapsed/failed bearing, however the real cause of the bearing failure is due to thermal damage caused by a preload fault. When the diaphragm fingers are worn to excess and the bearing face does not have a contact point on the diaphragm fingers, the outer race of the bearing will contact the fingers. This causes the outer race of the bearing to turn, resulting in the carrier becoming hot and subsequently melting. (Image 2).

Contact with the fingers is made at this point, resulting in thermal bluing.

Outer race will turn causing carrier to become hot and subsequently melt.

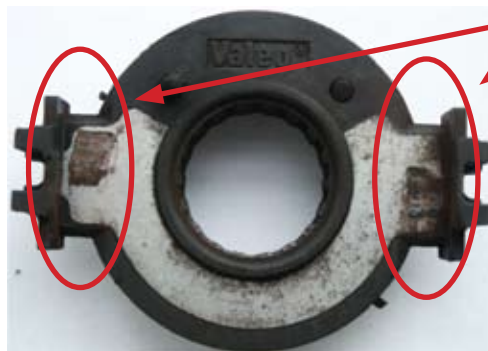
Image 3

The rear of the bearing will also display evidence of a heavy contact from the release fork seating pads. Heavy impressions can clearly be seen at the point the bearing locates onto the fork. (Image 3)

Heavy/deep impression from fork pads.

This is the result of a heavy contact being applied to the bearing from the release fork being partially seized due to worn pivot point bushes and worn release arm cross shaft. A thorough examination of the release mechanism should be carried prior to the refitting of the gearbox. This Issue is addressed in TSB CL005/08. Clutches returned to Valeo that clearly exhibit evidence of bearing preload will not be accepted under warranty.
