**T.S.B. No.:**  
CL005 / 08

**MARQUE:**  
Peugeot/Citroen/Fiat

**SUBJECT:**  
Heavy Pedal/Sticking  
Release Mechanism

**DATE:**  
March 2008

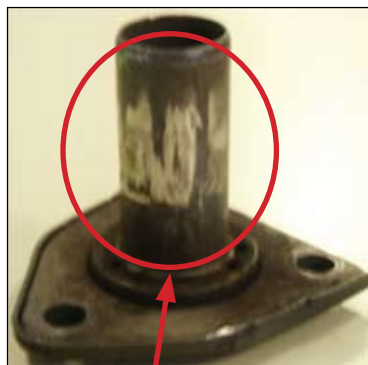
Image 1

Valeo Service UK Ltd Warranty Department see a high level of pull type clutches being returned with a common reason being reported. The fault described as unsmooth pedal action and heavy pedal feel with loss of adjustment is not attributable to the clutch. Inspection of the returned clutches have not found any faults or manufacturing defects. The fault lies with the clutch release mechanisms associated parts, including worn gearbox cross shaft bushes and heavily scored guide tubes.

*Image 1 shows a typically worn guide tube requiring replacement.*

*Wear and scoring to guide tube.*

The problem will re-occur after fitment of a new clutch if the worn parts of the release mechanism are not replaced. A close visual inspection of the guide tube will be necessary to identify if a replacement guide tube is required.
