Technical Services Bulletin

T.S.B. No.: CL011/09

PART No.: 826333

SUBJECT:Land Rover friction plate fitment guide

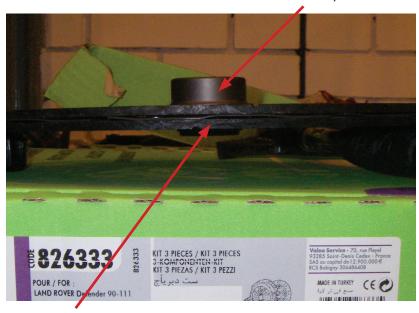
Valeo technical receive a number of calls about Land Rover clutch kit 826333 asking which way round the Friction plate should be fitted. Valeo warranty have received several clutches back with the fault of not able to engage gears or slipping / juddering. Examination reveals many are due to the plate being mounted the wrong way round. This bulletin has been produced to eliminate these issues.

The friction plate has an extended hub on one side.

The protruding hub can be seen in the picture below.

If the Friction plate is mounted with the protruding hub towards the gearbox, the hub hits the end of the spline on the gearbox input shaft before it has fully cleared the flywheel or pressure plate. This results in the friction plate dragging and results in difficult gear changes or the user unable to select gears.

Extended side of the drive plate hub to be fitted towards the flywheel.

Flat side of the drive plate hub to be fitted towards the gearbox.

This side is to be mounted towards the flywheel, not towards the gearbox unlike the majority of clutches.
