T.S.B. No.:
CSC002/08

PRODUCT:
Car Clutch

SUBJECT:
Over stroked cylinder

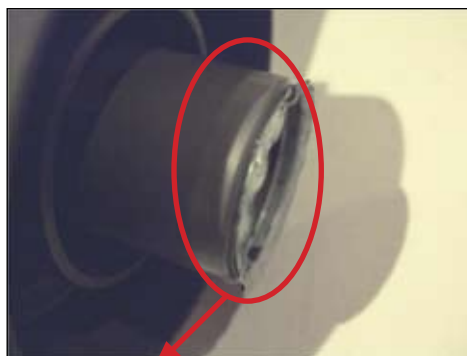
Image 1

Valeo Service Warranty Department have been receiving a high level of CSC units returned under warranty showing the bearing retaining ring distorted. Image1

The distortion to the retaining ring is a result of the bearing exceeding its maximum travel.

Retaining Ring Distortion

To avoid the cylinder being over stroked, the pedal should be depressed and then released slowly to allow the cylinder to return to rest before the pedal is depressed again. In some cases, the bleed nipple/pipe may need to be locked off after every downward stroke of the pedal, until some pressure in the system is achieved. This process may need to be carried out numerous times before some pressure is felt in the pedal. This is a common action required on Ford Fiesta/Puma/Ka when bleeding the system, as an air lock can occur within the clutch master cylinder. Valeo does not recommend the use of power bleeding systems, as some systems run a high air pressure. This can invert or roll the internal seal resulting in immediate fluid loss. Valeo will not accept any units returned under warranty that display evidence of being over stroked.

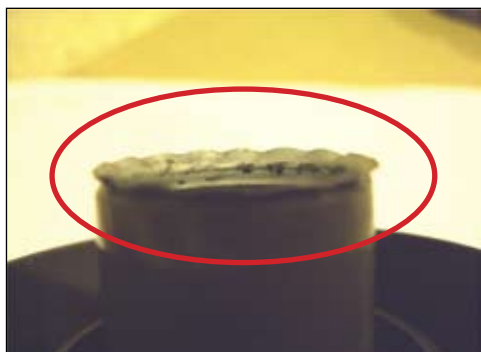
Image 2

The distorted retainer indicates that the bearing has been forced against the ring during the bleeding process, Image 2/3. This also damages the piston internal seal resulting in the loss of fluid past the seal.

Over stroking during the bleeding process is the result of the clutch pedal being pumped rapidly, which doesn't allow the cylinder to return to rest before the next pump stroke.
