Technical *Info*

Changing the CT 909 K5 timing belt kit for VW/Audi/Skoda/Seat 1.8 T/2.0 to the CT 909 K10

(Change from hydraulic tensioning damper to mechanical tensioning pulley)

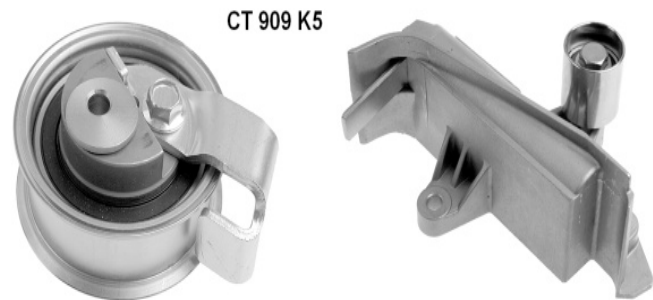
The components supplied in the timing belt kit do not match the components previously installed on the vehicle.

According to the OE manufacturer there is a new tensioning system with a mechanical tensioning pulley for the relevant vehicles specified in the catalogue. In this, the hydraulic tensioning damper with the small idler is replaced by a new version with just one bracket for the idler.

Fig. 1
Version to be replaced

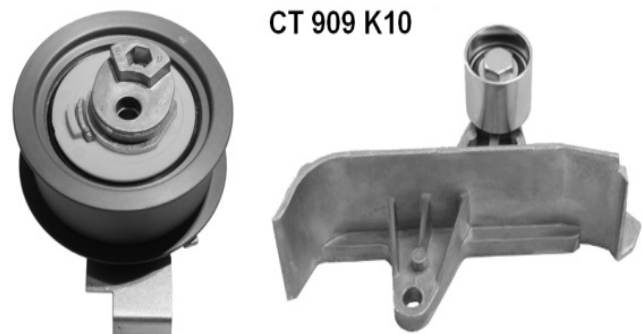
Fig. 2
New tensioning system

After fitting the timing belt and the bracket with the small idler, set the tensioning pulley to the mark by turning the eccentric clockwise. Check the setting after cranking the engine twice. Tighten the nut of the tensioning pulley to a torque of 23 +/- 3 Nm.
