**T.S.B. No.:**  
**CL004 08**

**PRODUCT:**  
**Car Clutch**

**SUBJECT:**  
**Fitting clutches with bent straps**

**DATE:**  
**April 2008**

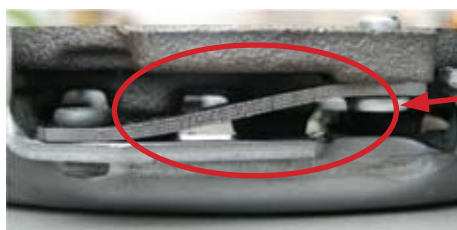
*Image illustrating how the drive strap should appear.*

Note:-the strips that make up the drive strap should be tightly packed together, with no kinks or bends, which should be consistent on all drive straps. Proceed with fitment.

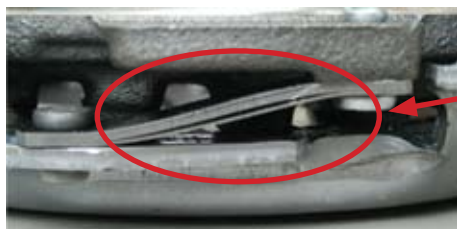
*Image illustrating a separation on the drive strap*

A separation on the drive strap will result in reduced pressure plate lift in this area of the cover, which may result in gear selection difficulties. Do not proceed with fitment.

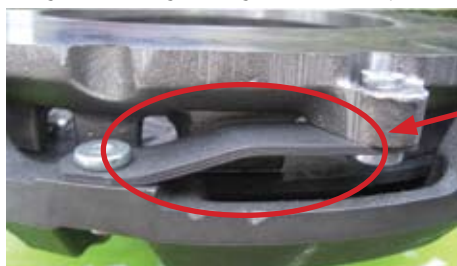
*Image illustrating damage to drive strap.*

A severe distortion or bend in the drive strap will result in complete loss of pressure plate lift in this area of the cover. This can cause severe gear selection problems. Do not proceed with fitment.

A clutch cover assembly drive strap that displays severe non conformity i.e. a bend or kink, will not function correctly, and should not be fitted. Selection of first and reverse gear will be greatly compromised, with the only rectification being to replace the clutch kit. We strongly advise that the clutch kit is inspected with particular attention being made to the cover assembly drive straps.
