| Clutch

| Clutch Plate

| Damaged Drive Plate

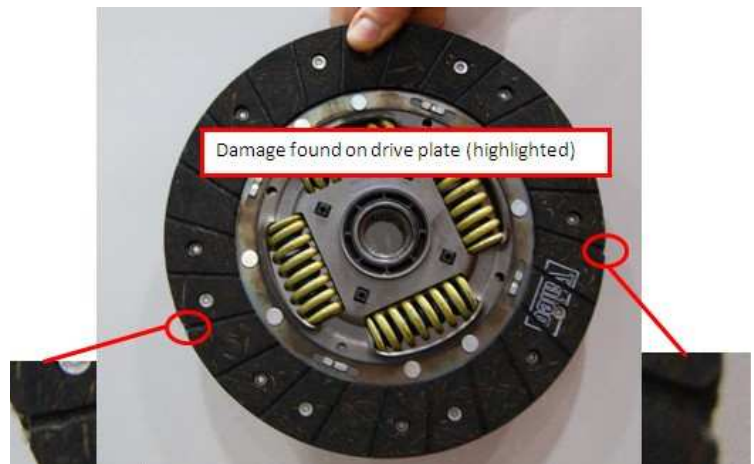
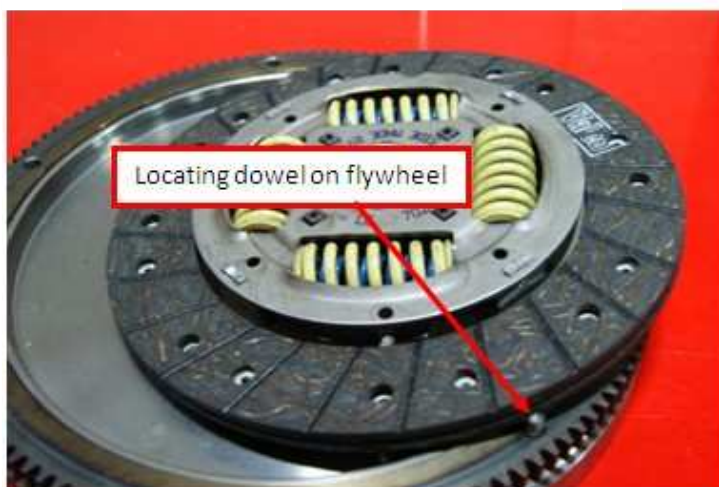
Valeo Service Warranty Department have received clutch and flywheel kits where damage has been inflicted on the clutch plate and this part cannot be used.

After investigating the damage the cause has been traced to the clutch drive plate coming into contact with the locating dowels on the flywheel. This issue will occur if the kit is not transported correctly.

Valeo clutch kits sold with flywheels **MUST ALWAYS** be transported and stored horizontally. If the kit is transported vertically, the clutch cover could become detached from the flywheel and allow the drive plate to move between the two parts.

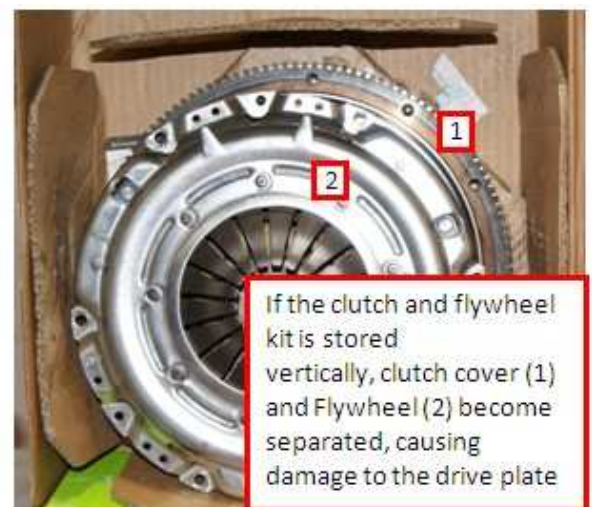
Image showing how clutch plate becomes damaged from locating dowels on flywheel
