| Clutch

| Grease

Grease Contamination

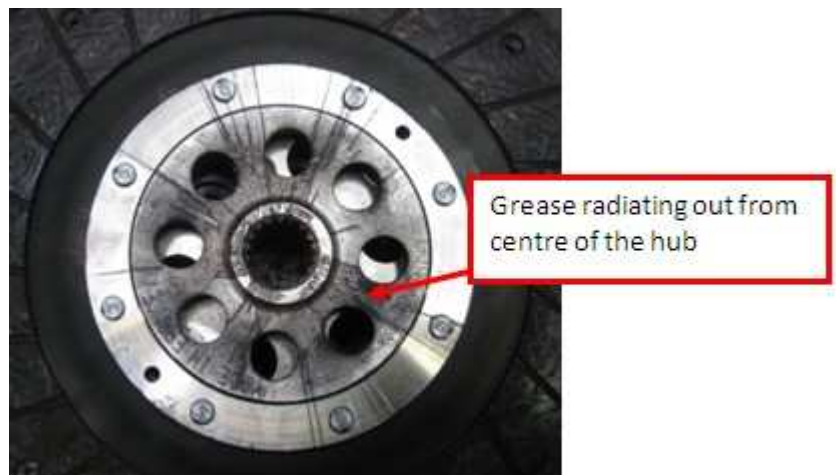
After inspecting the returned parts, there is clear evidence of too much or incorrectly applied grease which has radiated from the drive plate hub from centrifugal force and coated the friction surface.

Once the grease has come into contact with the friction surface, the coefficient of friction of the drive plate is reduced so it can no longer transmit all of the engine torque resulting in the effect of juddering or slipping.

To reduce the chance of this effect, always use the correct, high temperature grease suitable for use in clutch environments. Copper based grease is unsuitable for use due to its low viscosity.

When applying grease during clutch fitment, coat the gearbox input shaft with the correct grease then wipe the excess off leaving only a thin film. Too much grease when the input shaft is rotating at engine speed will force the grease outwards onto the clutch drive plate and pressure plate and cause juddering or slipping.

DO NOT APPLY GREASE DIRECTLY TO THE SPLINES ON THE DRIVE PLATE HUB. The grease will be pushed out from the splines during installation of the input shaft and allow it to accumulate on the outside of the hub.
