T.S.B. No.:
CL015/09

PRODUCT:
Clutch

SUBJECT:
Broken or damaged locating tabs

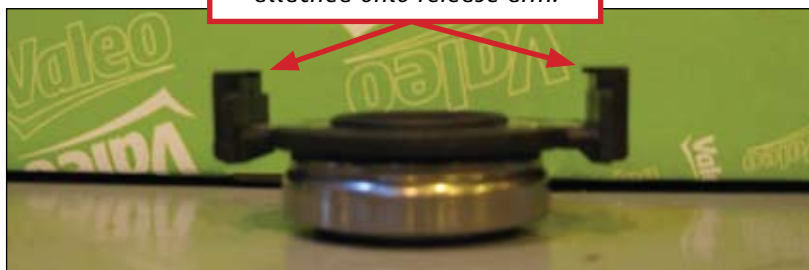
Release bearing

Valeo warranty have received a number of returned clutches due to the bearing locating tabs having been damaged in transit or broken in the box. However, after inspection it can be seen that the clutch cover and plate have been fitted or the bearing shows signs that it has been attempted to be fitted, subsequently breaking.

Tabs can be easily broken if not attached onto release arm.

To ensure the customer does not receive a broken bearing, it is recommended that the member of staff who is selling the clutch kit to the customer removes the bearing from the kit and inspects it to ensure the locating tabs are there and does not show signs of damage. Also ensure the person fitting the clutch checks the bearing.

When fitting the bearing, to reduce the risk of damaging the locating tabs, the release bearing must be fitted to vehicle manufacturers guidelines.

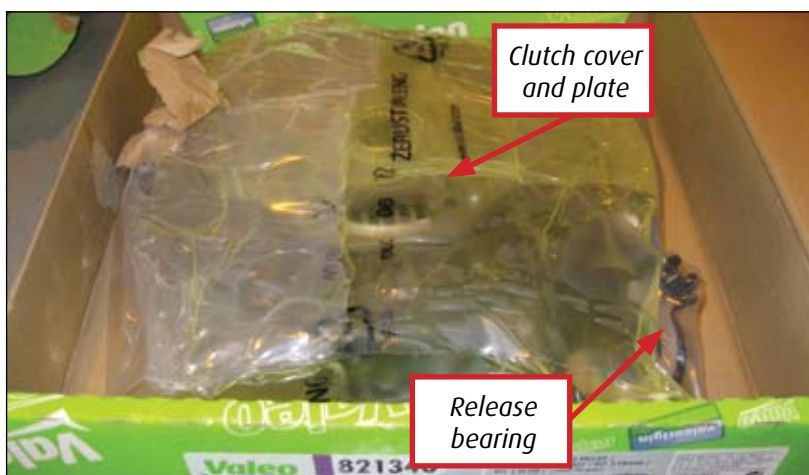
Release bearing sealed in box

Valeo will not accept a returned clutch with a damaged bearing if there are signs of fitment or the packaging has been opened.
