| Clutches | Solid Flywheel Conversion Kit | 835013 | Mercedes

Vibration occurring in the vehicle

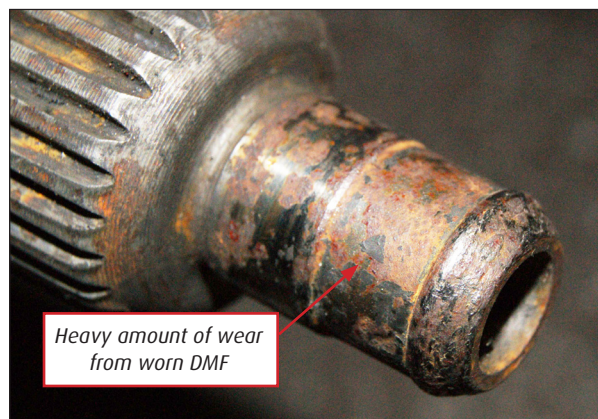
Also when changing the clutch and flywheel assembly to 835013, the gearbox needs to be checked for any wear on the first motion shaft and excessive play in the bearings. Any wear to the bearings or the first motion shaft will cause a harmonic frequency to be amplified through the gearbox assembly, producing the vibration. Below are some images of an example gearbox with a high amount of wear in the first motion shaft and a large amount of play in the bearings.

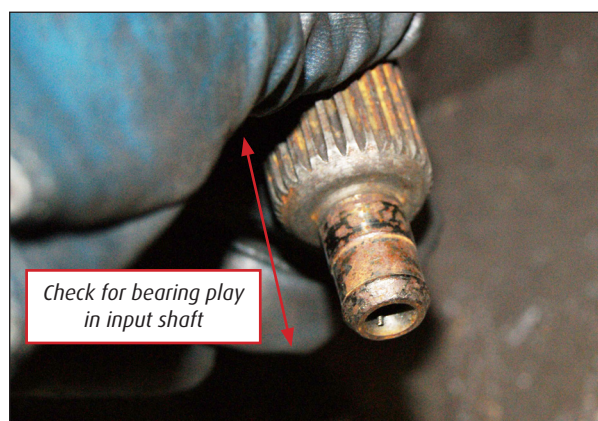
When the gearbox is mounted after having a conversion kit fitted, care needs to be taken to ensure the input shaft is mounted into the spigot bearing in the flywheel centrally and the gearbox needs to be fully supported to ensure the first motion shaft is not allowed to damage the pilot bearing. If the pilot bearing is damaged, the first motion shaft will not be fully supported or can cause the shaft to rotate eccentrically. This will then produce a vibration in the gearbox and will accelerate wear on the gearbox components.

Right is an image of the pilot bearing damaged in a flywheel that was returned for a vibration issue.
